WATERFORD, CONNECTICUT
MILLER POND DAM
00154

PHASE I INSPECTION REPORT
NATIONAL DAM INSPECTION PROGRAM

AUGUST 1980

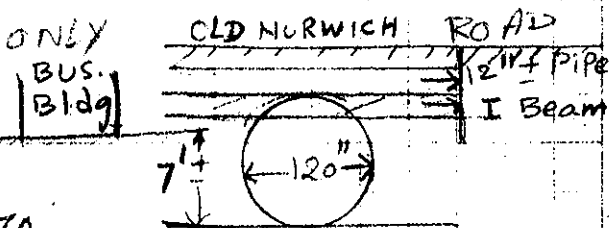
THE BUILDING ADJACENT TO
 THE CULVERT AND CONTAINING SEVERAL BUSINESSES,
 IS $3' \pm$ BELOW THE CROWN AND THEREFORE WILL
 BE FLOODED BY $2.6' \pm$ FEET OF WATER. A PORTION OF OLD NORWICH
 RD, WHICH IS A WELL TRAVELED ROADWAY WOULD
 BE SUBMERGED AND IT IS LIKELY THAT
 TWO DWELLINGS ADJACENT TO THIS CULVERT
 WOULD ALSO BE IMPACTED WITH $2' \pm$ FEET OF
 FLOOD WATER.

THUS, THE PEAK FAILURE OUTFLOW WOULD RESULT IN FLOOD
 OF A MAGNITUDE THAT WOULD IMPACT AT LEAST FIVE
 HOUSES, A BUILDING CONTAINING SEVERAL BUSINESSES AND
 THREE CULVERTS. IT IS REPORTED THAT ONE OF THESE
 CULVERTS, $2200' \pm$ FT. D/S OF THE DAM WAS WASHED OUT
 DUE TO A RECENT FLOODING.

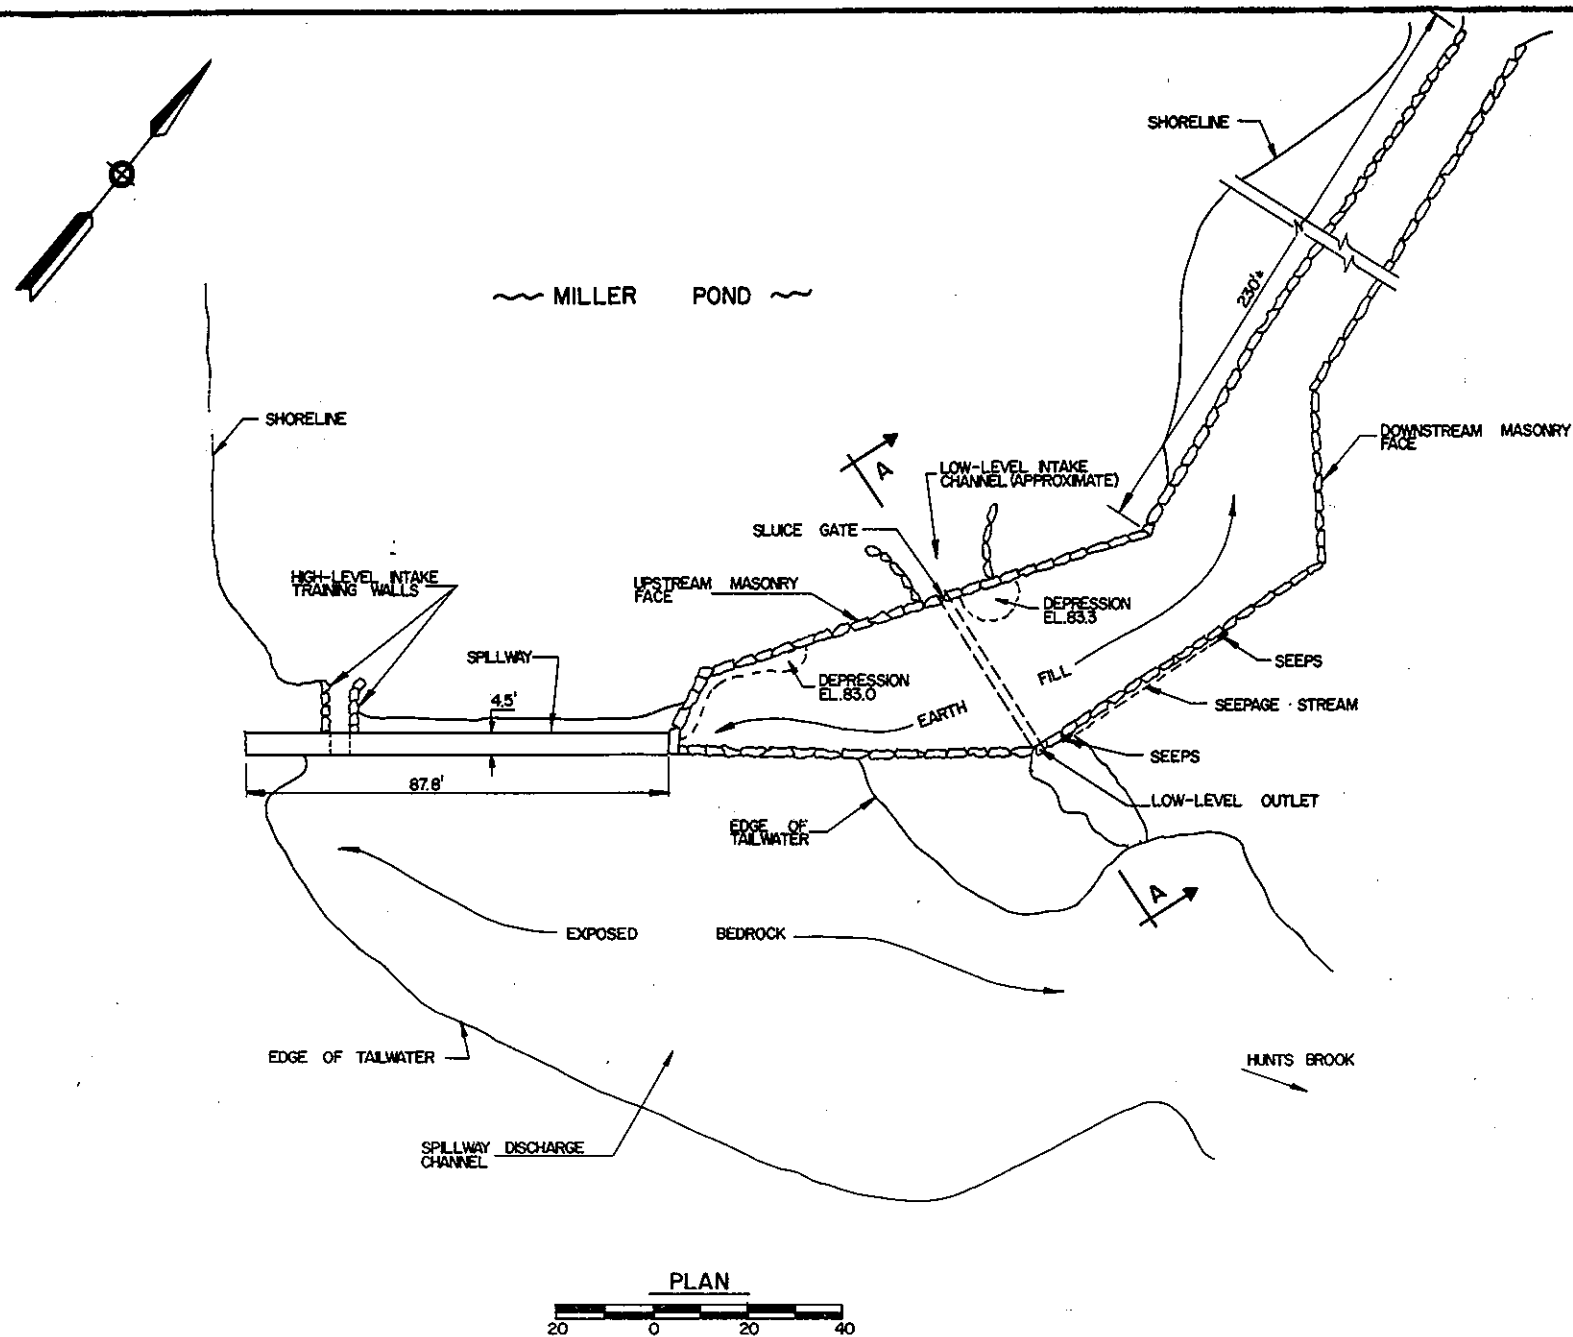
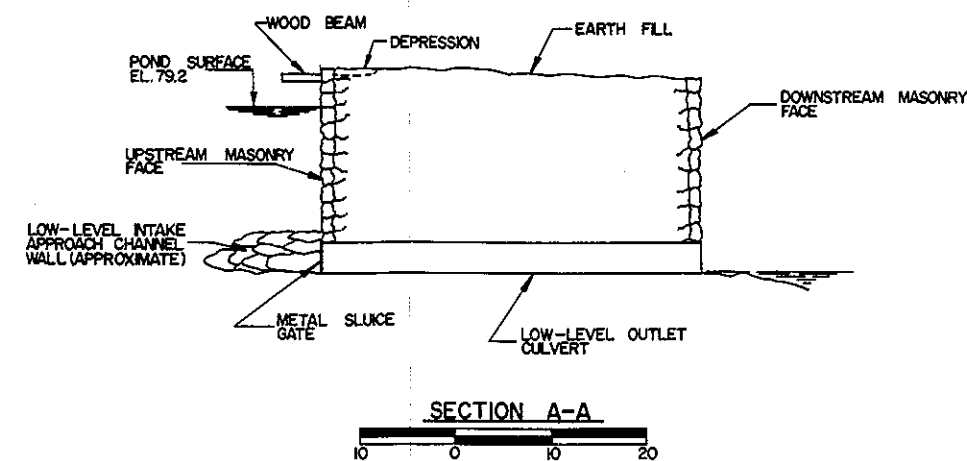
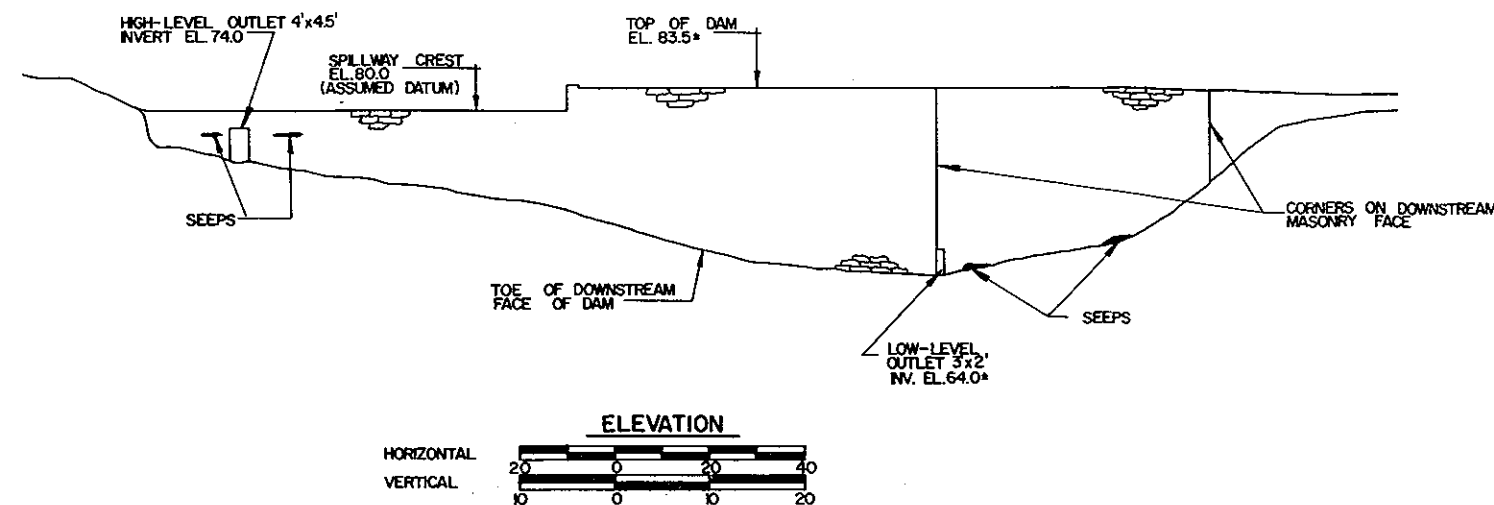
b. Description of Dam and Appurtenances - As shown on Sheet B-1, the 20 foot high dam is a masonry and earthfill gravity structure, probably founded on bedrock for its entire length. The project is approximately 425 feet in length, consisting of an approximately 335 foot long dogleg shaped earthfill section with upstream and downstream vertical masonry faces and an 87.8 foot long masonry spillway. There is a high-level outlet through the spillway section and a low-level outlet through the earthfill and masonry section.
